Inspection and Data Collection Protocol to Monitor Performance of Biotic Soil Technology

Case Study #1 - Rehabilitation of Abandoned Residential Site Development:

Case Study #2 – SCDOT Cypress Gardens Road:

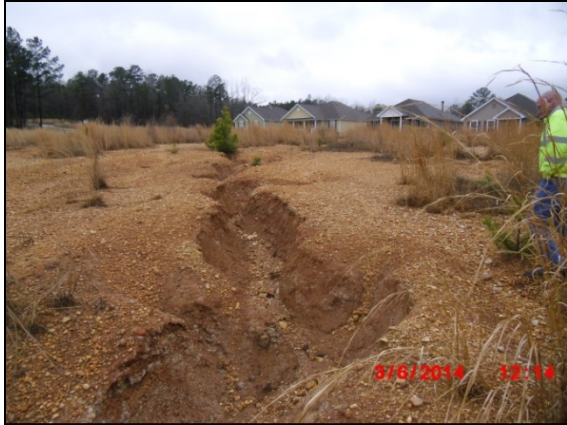
Figure 1 – Denuded and barren site conditions

Soil test results confirmed very low OM ($\leq 1\%$), acidic conditions and a lack of available nutrients to support growth of vegetation. The contractor's first option to improve site conditions was to identify a nearby source of high quality topsoil to accommodate a 10 cm (4 inch) depth over the re-graded substrate. A second option was to consider using BSTs to add OM, biostimulants and other soil building components directly to the denuded substrate.

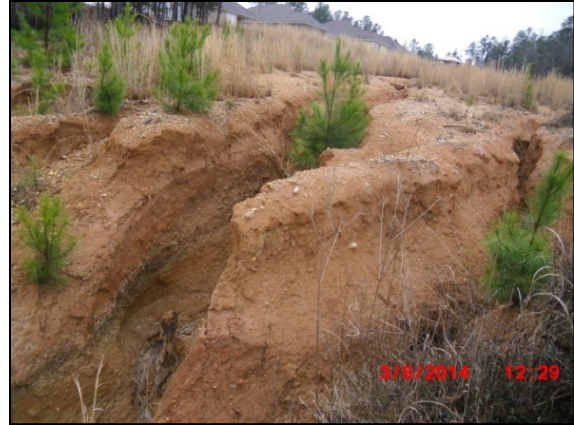
Figure 2 – Acidic soils with low organic matter

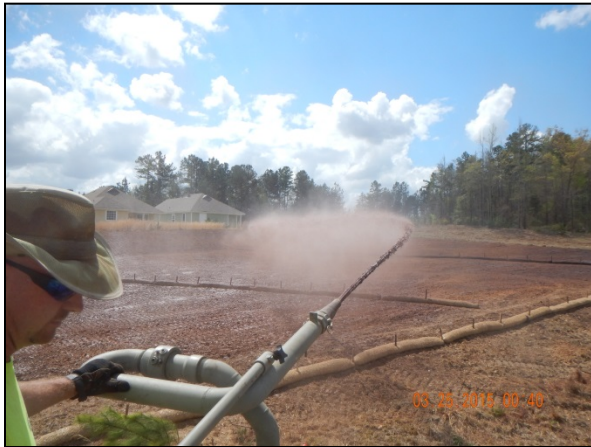
Figure 3 – Application of BST on level areas

Grading of the site substrate to remove gullies, rills and prepare the seedbed commenced in Mid-March of 2015. The flatter areas were leveled and left in a rough condition while the slopes were cat tracked to reduce potential runoff creating pockets and ridges to hold water and seed for quicker growth. Installation of the BST, seed, and soil amendments as well as all erosion and sediment control measures was completed on March 25 in just one day.

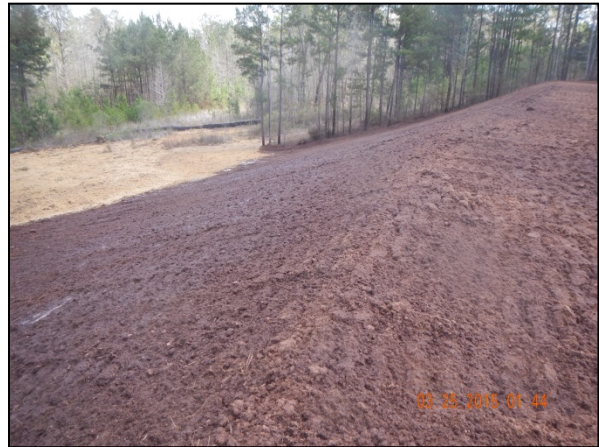
Figure 4 – Cat tracked slope treated with BST

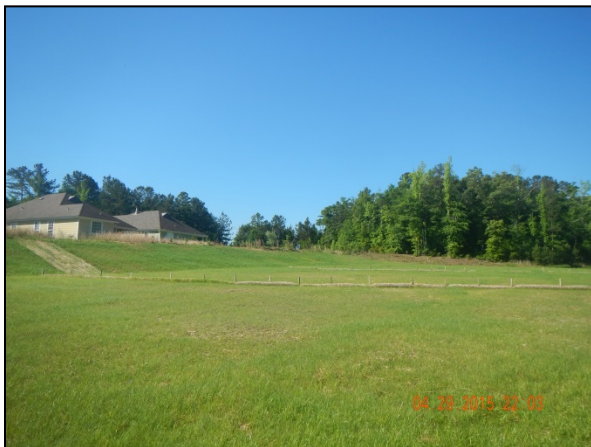
Figure 5 – Growth over “Ghost Clay” on flat areas

Wet conditions prevailed soon after the installations and over the month of April with the site receiving nearly 356 mm (14 inches) of precipitation. Despite the heavy rainfall amounts minimal erosion was observed. Some of the flatter areas were topped with an exposed very light colored, material known locally as “Ghost Clay”, which led to some ponding and overland flow down over the 3H:1V slope. Degradable erosion control blankets were installed with additional seed in two areas where concentrated flow had caused some spot erosion. Meanwhile rapid and dense vegetative growth flourished within 5 weeks as highlighted in Figures 5 and 6.

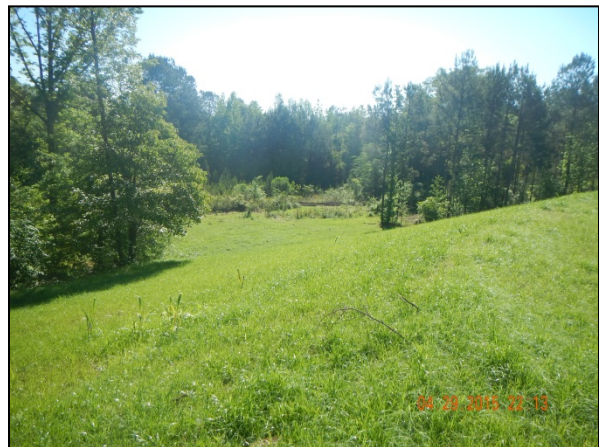
Figure 6 – Luxuriant growth on 3H:1V slope

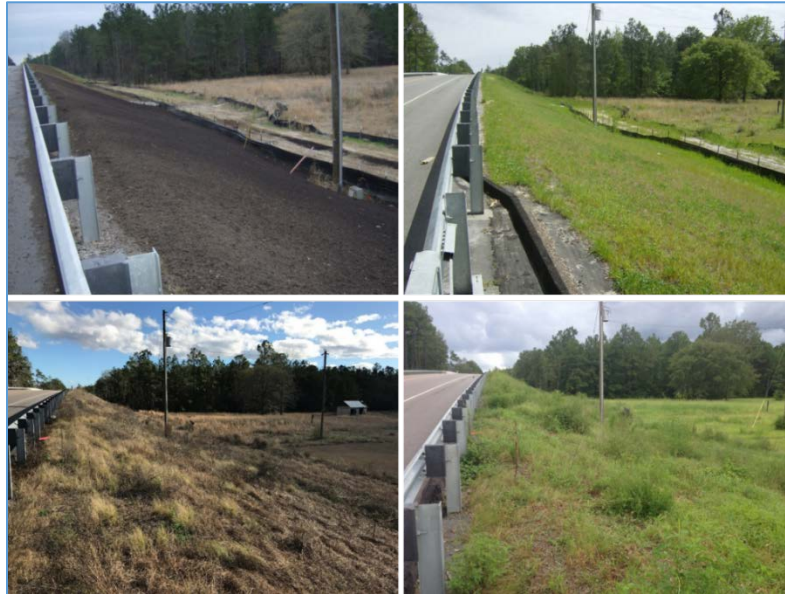
Figure 7 – Photographs of compost demonstration plot, clockwise from top left: January 2016, April 2016, September 2016, and January 2017.

Organic amendments helped establish vegetation and prevent erosion on a site where traditional seeding practices were repeatedly not successful and topsoil was not a feasible solution. Minor rill erosion was observed on the compost plot shortly after the application prior to the establishment of vegetation. Erosion was not observed on the HBSA plots prior to the establishment of vegetation. On all plots, the nurse crop (Rye Grain) emerged in early February and provided a sufficient stand of temporary cover through March and April. This demonstrated that soil amendments are capable of providing rapid growth of temporary cover species even during difficult periods of the growing season.

longer, achieving a sufficient stand of permanent vegetation by late September. This transition period from temporary cover to permanent cover took longer than anticipated because the dense temporary cover inhibited the establishment of the permanent cover. This observation indicated that when using soil amendments, temporary nurse crop seeding rates may need to be reduced to ensure permanent vegetation establishment is not slowed or choked out.

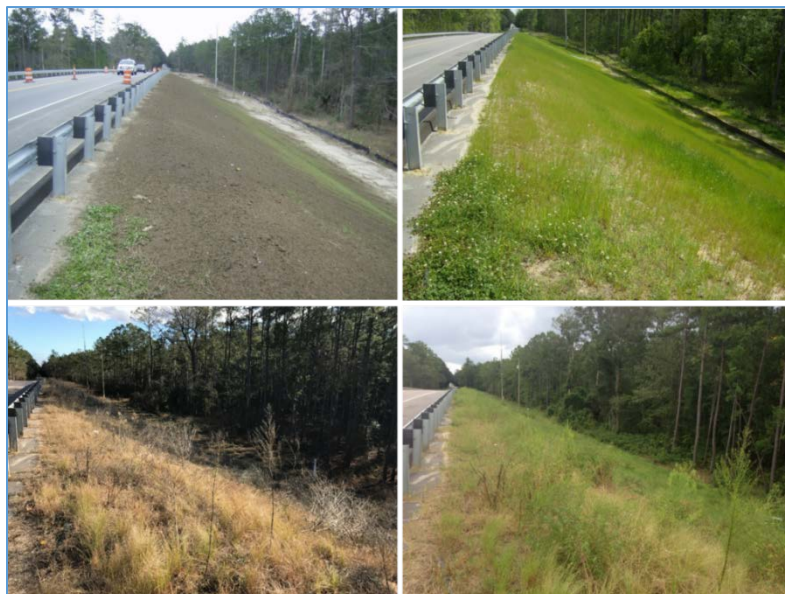
Figure 8 – Photographs of 1-Step HBSA demonstration plot, clockwise from top left: January 2016, April 2016, September 2016, and January 2017.

In May as the temperatures increased, the cool season nurse crop gave way to the permanent species in the seed mixture (Bermuda grass and Weeping Lovegrass) as well as volunteer grass and weed species. The HBSA plots achieved a sufficient stand of permanent vegetation (a uniform perennial vegetative cover with a density of 70% of each square yard of the seeded area) by late July. The compost plot took slightly

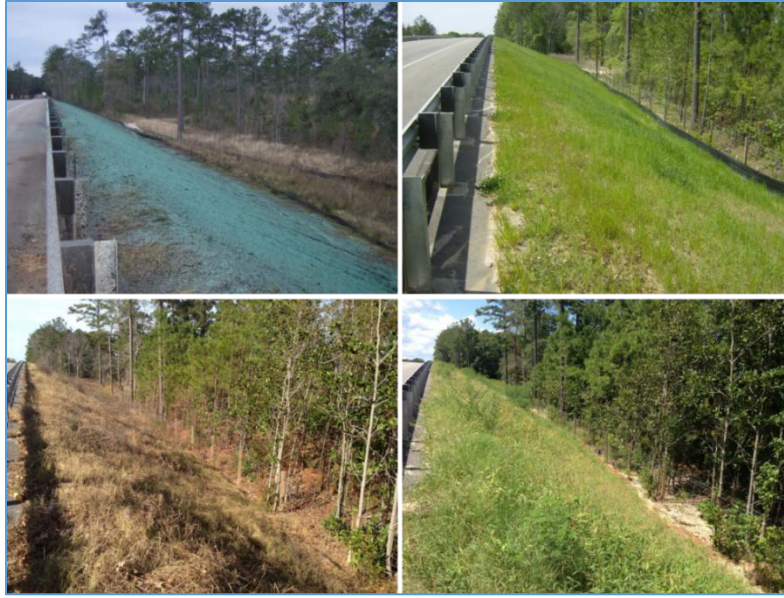
Figure 9 – Photographs of 2-Step HBSA demonstration plot, clockwise from top left: January 2016, April 2016, August 2016, and December 2016.
