RESTORING HISTORIC STRUCTURES TO MEET TODAY'S ENGINEERING STANDARDS

Sensitively Restoring Historic Structures to Meet Today's Engineering Standards

BY FRANK MONASTRA, P.E., LEED AP

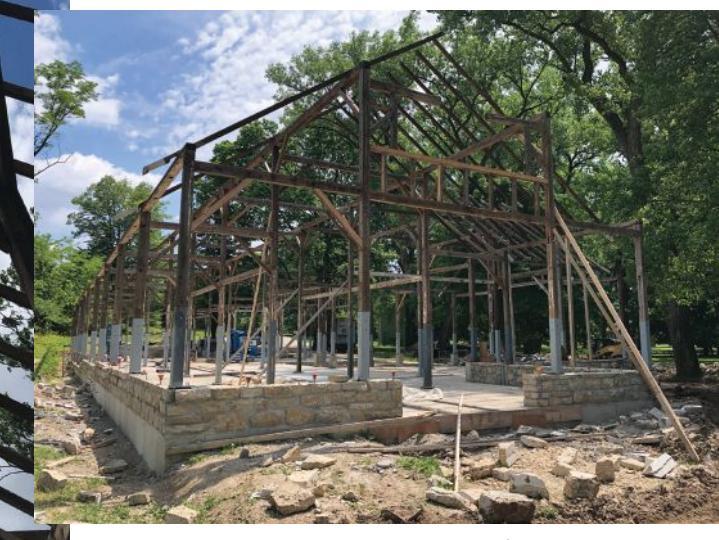
Built in 1901 and located on the original Montgomery County Fairgrounds in Dayton, Ohio, Barn No. 17 has been completely disassembled and rebuilt a little more than a mile away at its new location in Carillon Historical Park.

Contractors are nearly finished with the relocation and restoration of the historic Barn No. 17 that served as a horse stable since 1901 at the recently repurposed Montgomery County Fairgrounds. The project began in April 2019 as workers completely deconstructed and reconstructed the barn one plank of wood at a time—at its new location.

Barn No. 17 is a large, true timber-frame structure that served as a support building rather than housing public exhibitions. It served as a place to prepare for the next activity or rest after a long day and was a "silent witness to 120 years of county fairs, races and a whole host of special events," says Brady Kress, Dayton History president and CEO.

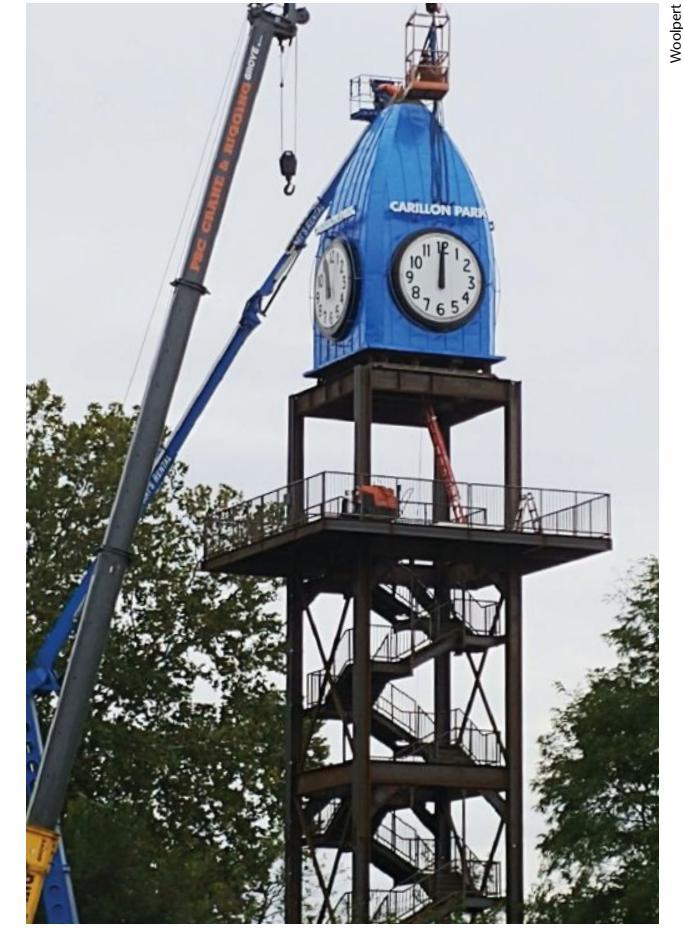
The historic Callahan Clock was built in 1892 and originally located atop Dayton's first skyscraper. The clock was preserved when the building was razed and is now installed atop the Brethen Tower in the city's Carillon Park.

Woolpert provided civil and structural engineering for the 100-foot observation tower with observation viewing available at 75 feet. Funding from the local Brethen Foundation enabled the preservation of a significant piece of local history through the installation of the clock in the park. Kress called the project a dream the organization had since it adopted the clock in 2006.

To determine the design for the tower, Woolpert collaborated with Kress and architect John Roll, president of Roll & Associates, to determine the aesthetics and desired architectural features. Woolpert designed a traditional steel-frame structure using weathering steel material, which develops a protective rust coating and provides an industrial aesthetic. The tower's deep foundation system consists of 12 augercast piles that extend 40 feet into the ground. The steel frame will resist forces generated from a 90-mph windstorm.

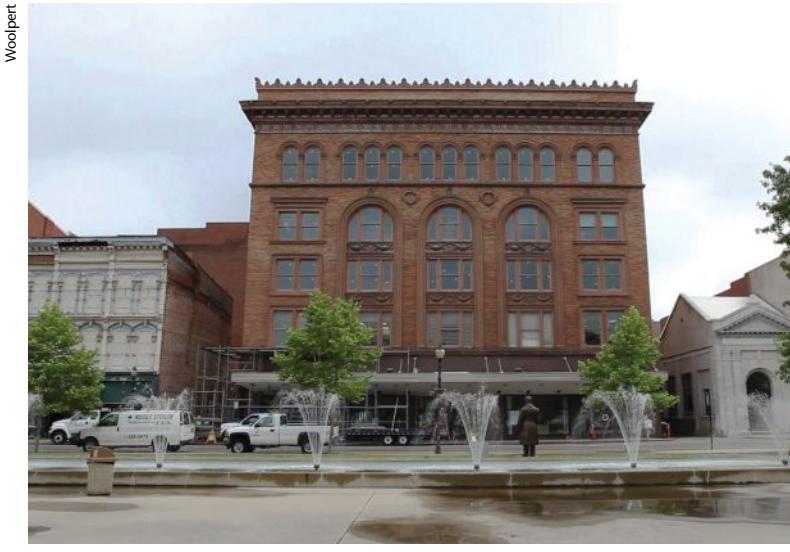
The 150,000-square-foot Bushnell Building in Springfield, Ohio, is among the 95,000-plus structures on the National Register of Historic Places. The building was completely renovated and modernized, earning LEED certification.

When Jim Beck, Woolpert engineering lead, became involved with the project, the building was in poor condition. Beck and the Woolpert team faced the challenge head-on to convert an "energy hog" of a building to meet the LEED concept of not consuming more materials than necessary. The first simple changes, such as enclosing the building to prevent heat loss and improve operations of the building's systems, resulted in energy savings and improved the interior environment for occupants.

Saving energy continued through the installation of ventilation sensors, which bring fresh air into the building whenever carbon dioxide emitted by occupants is detected in a room. Daylight harvesting sensors were installed to turn off LED lights in rooms when there's enough sunlight coming in from windows. In addition, a water-source heat pump recycles waste heat from one part of the building for use elsewhere in the building. "Often when people design buildings, they don't really consider energy savings," adds Beck. "Smart building controls allow you to use energy efficiently."

Installation of new, energy-efficient windows was permitted by the Ohio Historic Preservation Office, and each had to strictly adhere to historic guidelines and inspection. Trims around the windows were required to be dimensionally accurate to maintain the historical façade.

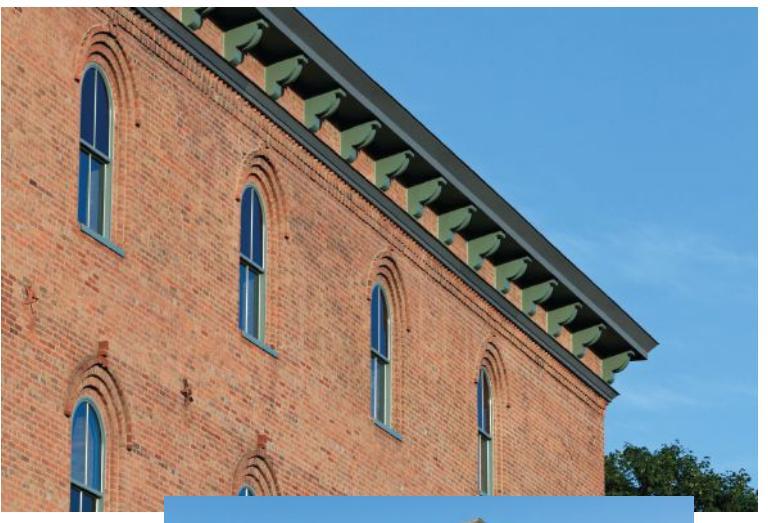
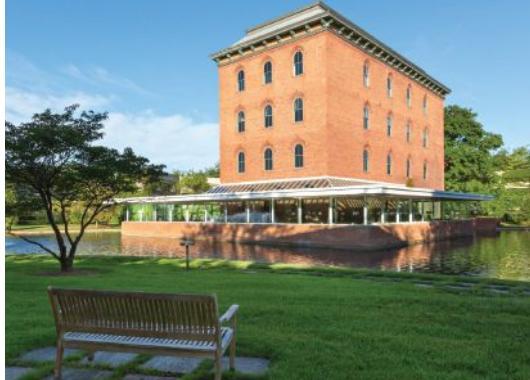
Restoration of the Cerealine Building in Columbus, Ind., built in 1880, transformed the historic structure from an old, dilapidated factory into a beautiful, modern conference center.

Cummins wanted to restore the Cerealine Building for use as a conference center on its campus, but the building had been changed several times through the years. Floor lines didn't match up with windows. The HVAC system from a previous renovation was inadequate for the building and couldn't be repaired. The roof was failing.

A key design task was ensuring the look of the building's historic exterior was maintained. New energy-efficient windows matching the original windows—curved at the top with similar panes and mullions—were installed into the same window openings without changing the size or location. The beautiful brick exterior also was preserved. A new roof shored

up the envelope of the building, and a state-of-the-art HVAC system was installed to provide heating and cooling throughout the entire building.

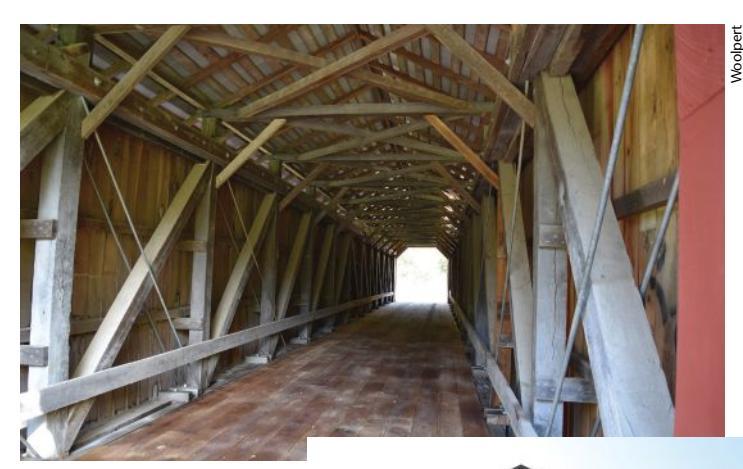
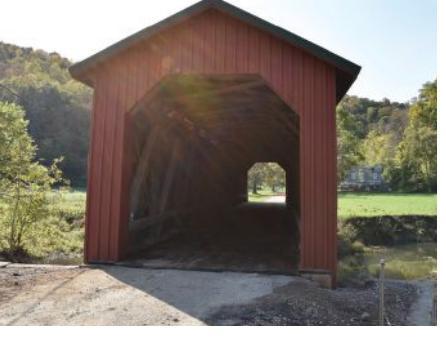
Built in 1886, the Foraker Covered Bridge over the Little Muskingum River near Graysville, Ohio, was completely rehabilitated after its 92-foot span had begun to sag. The work was completed in 2016, and the project earned the Historic Bridge Award as presented by the Federal Highway Administration, Ohio Department of Transportation, State Historic Preservation Office and the County Engineers Association of Ohio.

In 2017, such detailed attention to restoration methods led to Mattox and Woolpert Engineer Tom Less being awarded Ohio's Statewide Historic Bridge Preservation Award for their work on Monroe County's Foraker Bridge, built in 1886. A previous restoration project left the 92-foot-long bridge sagging 11 inches.

While historic restoration is a goal, meeting modern safety standards means installing steel rods under the floor to help carry heavy loads, shifting from wooden shingles to metal sheeting to decrease weight, and spraying fire retardant over the interior of the bridge.
